Model: 175/275/350/500/750 Ton Top Drive Serial #: All	Jul. 7, 2015
Product Bulletin # TDS-138 <b>Alert</b>

## Guide Runner Adjuster Bolts

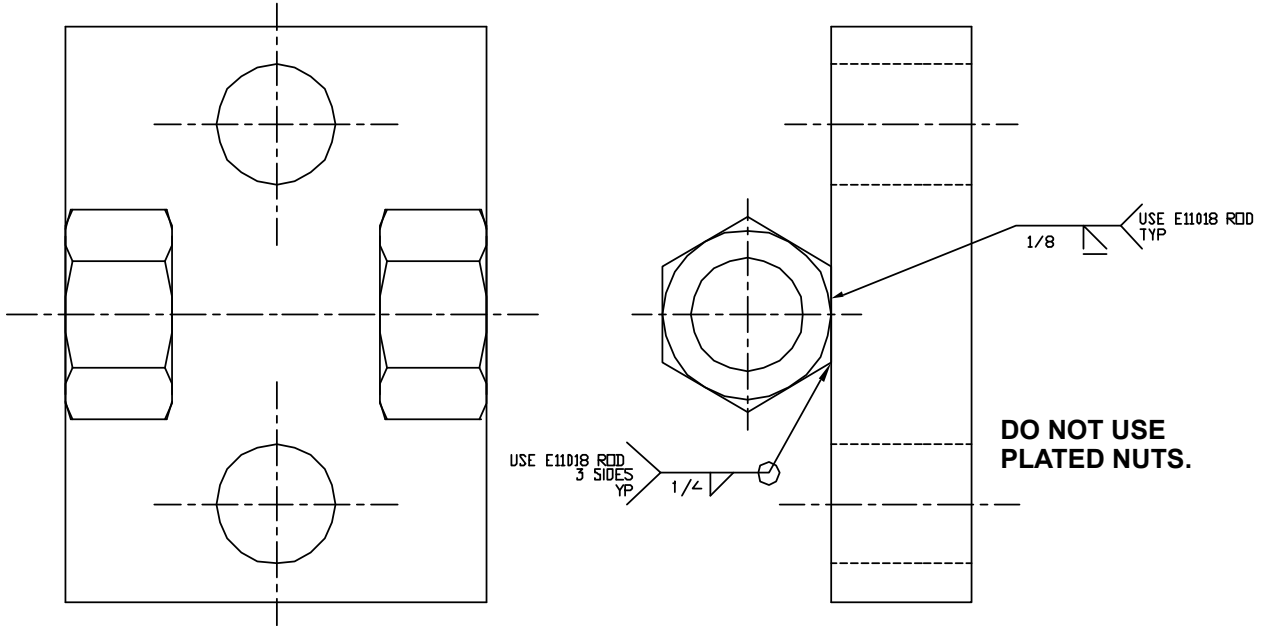
Figure 1: Adjusting Clamp Weld Detail

If the weld holding the adjuster bolt nut in place fails and causes the nut to separate from the adjuster plate, it is possible for the adjuster bolt to work loose and fall from the Top Drive. The adjuster bolt nut must be properly welded to the adjuster plate on all four sides.

1. Inspect each adjuster nut and ensure there are penetration welds on all four sides of the nut. If any of the nuts are not welded on all four sides, either upgrade the welding as shown in Figure 1 or order new adjuster plates as required (see Table 1 and Table 2).
2. Install safety wires on the adjuster bolts (see Figure 2 on page 3) as follows:
  - a. Secure a loop of safety wire around the adjuster bolt shaft, between the bolt head and the adjuster plate nut. Ensure the wire is loose enough to allow the bolt to turn, and tight enough that the bolt head cannot pass through the wire loop should it become detached from the adjuster plate.
  - b. Secure the loose end of the safety wire such that the adjuster bolt and nut will not fall to the ground should the adjuster nut become detached.
