Model: EMI-400

Product Bulletin # TDS-198

VFD Safety Relay Wiring

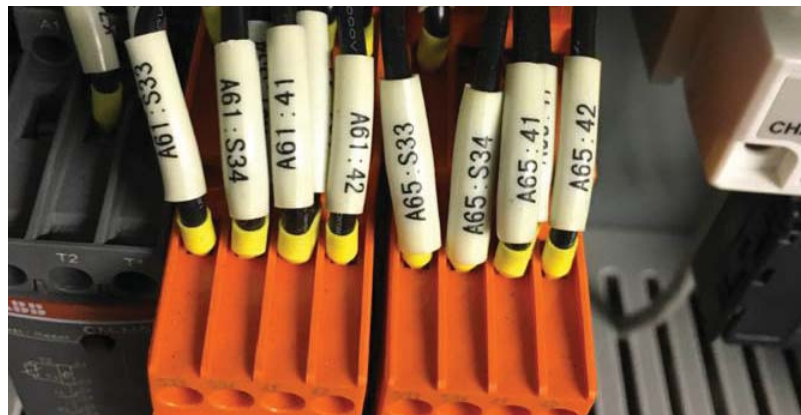
Figure 1: Locate Relays A61 and A65

It has come to Canrig's attention that the original equipment manufacturer may have wired some EMI 400 HP VFD houses incorrectly. Only VFDs with ABB ACS880 safety relays were affected. This has been corrected for new builds, but existing VFDs should be inspected and the problem corrected if discovered.

1. Inspect VFD house to verify if problem exists. **A visual inspection involves placing personnel in proximity to potentially hazardous energy, and should be performed only by qualified personnel.**
2. Lock Out/Tag Out VFD so that the VFD is no longer energized.
3. Locate two safety relays marked **A61** and **A65**, which are orange in color and are located side by side.

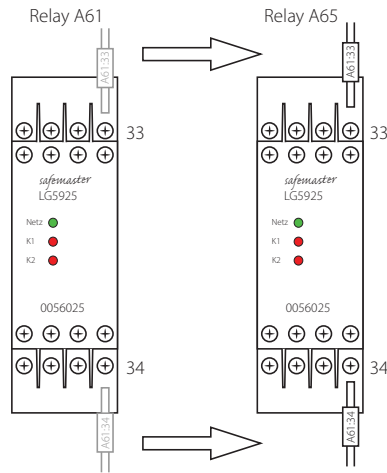
Figure 2: Move indicated wires from relay A61 to A65, plugging into same terminals

4. Move the wire marked A61:33 on relay A61 to the relay A65 to terminal **A65:33**.
5. Move the wire marked A61:34 on relay A61 to the relay A65 to terminal **A65:34**.
